U. S. ARMY

Technical Note 5-70

NOISE REDUCTION OF THE XM759 CARGO CARRIER (MARGINAL TERRAIN VEHICLE)

HUMAN ENGINEERING LABORATORIES

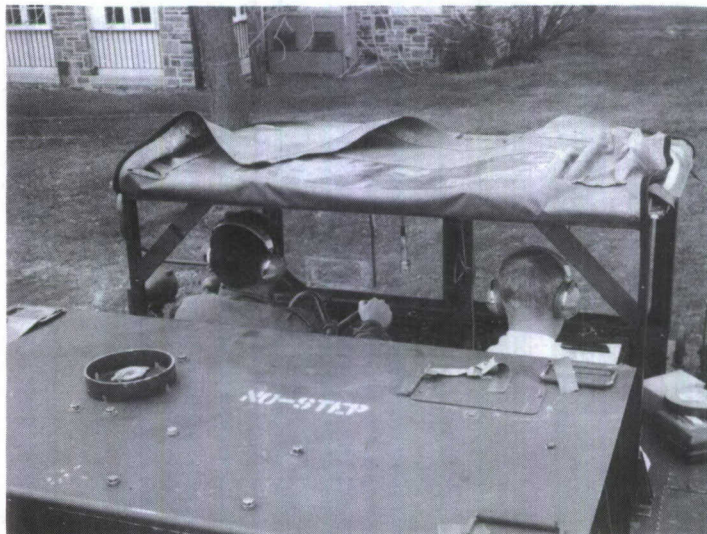
Fig. 4. VIEW OF THE MICROPHONE MIDWAY BETWEEN THE DRIVERS' HEADS WITH CURTAINS UP (OPEN CAB)

All of the cab measurements were made with the microphone located midway between the heads of the driver and the assistant driver (Fig. 4). In most cases, the microphone was suspended from the cab ceiling with the microphone facing down. In a few cases when the cab was completely open and there was nothing over the drivers' heads, the microphone was held by hand, facing up, midway between the drivers' heads.

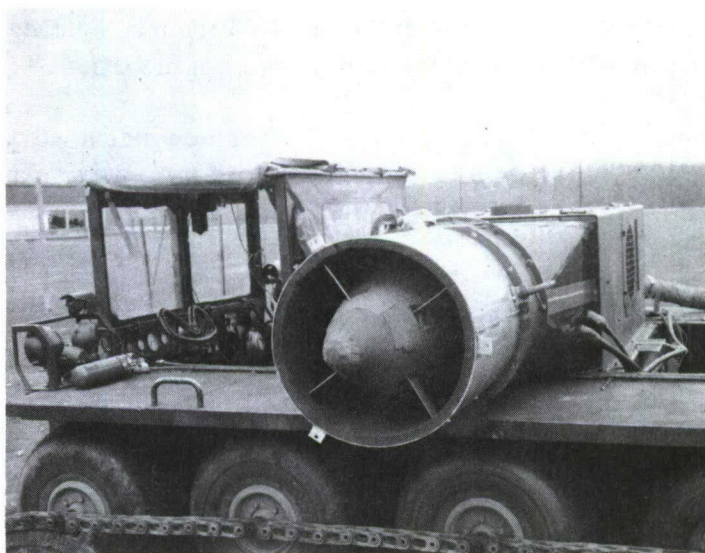
Fig. 11. CARR-KALEN ATTENUATOR ON PILOT VEHICLE NO. 2

The C-K Attenuator was attached to the fan housing and measurements made in the cab (closed and open) at 2000, 3000 and 4000 rpm. Testing was stopped at this time because the fan belts had been burned by the engine exhaust.
